**Flood Control Project Maintenance  
Levee Inspections****LMA District Cover Sheet  
Spring 2015 Levee Inspection Results****American River Flood Control District**

**Spring 2015 Levee Inspection Results**

**American River Flood Control District**

Waterway			Bank	Unit Miles
Unit No. 01 Arcade Creek			Left	2.08
	Spring (March - May)	Summer (June - August)	(September - November) Fall	Winter (December - February)
Unit Maintenance Rating (Fall Only)				
Date of Inspection	04/30/2015 - 04/30/2015			
DWR Inspector	Maksim Khashchuk			
Accompanied By	Richard Marck ARFCD

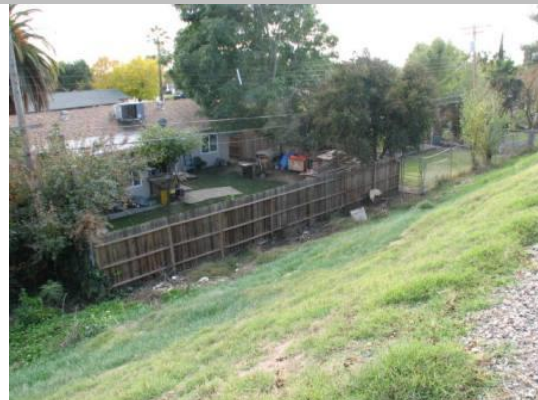
Photo 1 of 1 : SP\_2015\_NA0001\_51\_183\_20150317\_00045.jpg

11/17/2011 Wooden privacy fence.

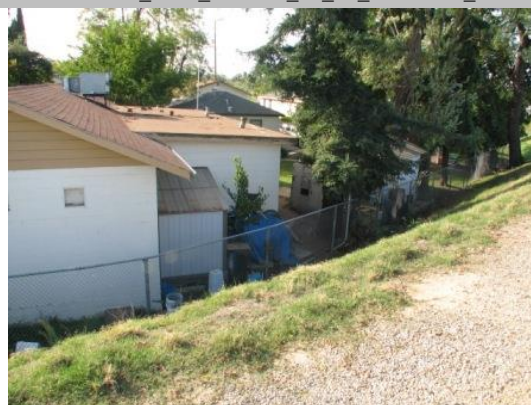
Photo 1 of 1 : SP\_2015\_NA0001\_51\_18\_20150317\_00016.jpg

Action/Comments					
Building Inspector Comments: Cement block building within 10-ft of toe.

Fall 2009 photo: Buildings and fence near levee toe.

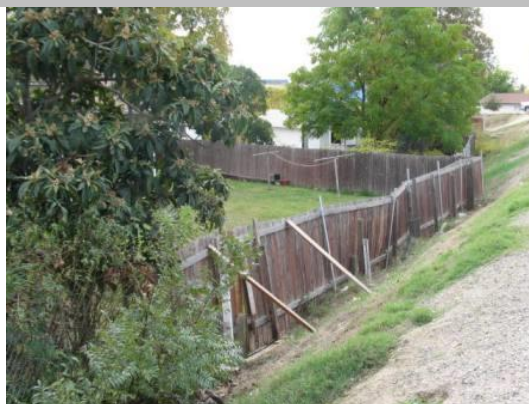
Photo 1 of 1 : SP\_2015\_NA0001\_51\_17\_20150317\_00015.jpg

11/17/2011 Wooden privacy fence built at the levee toe. Levee slope is being used to support the fence.

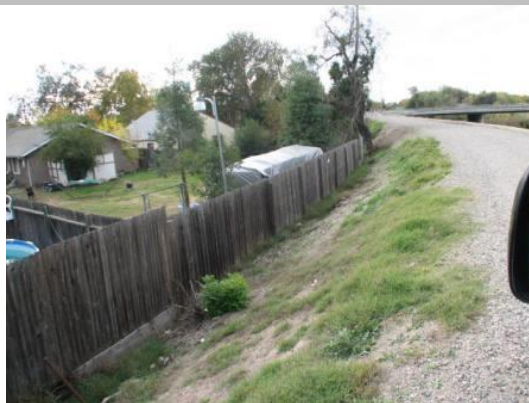
Photo 1 of 1 : SP\_2015\_NA0001\_51\_16\_20150317\_00014.jpg

11/17/2011 Wooden privacy fence built at the levee toe.

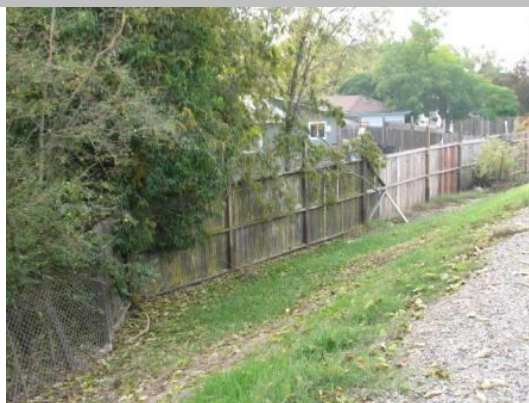
Photo 1 of 1 : SP\_2015\_NA0001\_51\_12\_20150317\_00010.jpg

11/17/2011 Wooden privacy fence built within 15' of the levee toe.

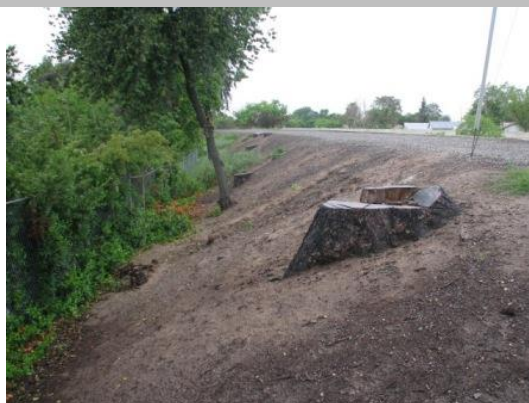
Photo 1 of 1 : SP\_2015\_NA0001\_51\_56\_20150317\_00033.jpg

Several large stumps on levee slope.

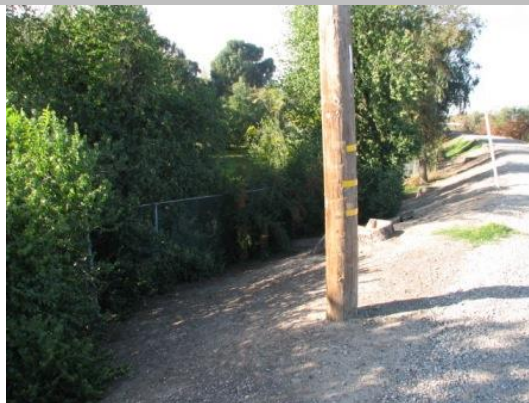
Photo 1 of 1 : SP\_2015\_NA0001\_51\_35\_20150317\_00027.jpg

Fall 2009 photo:Vegetation obstructing visibility near levee slope.

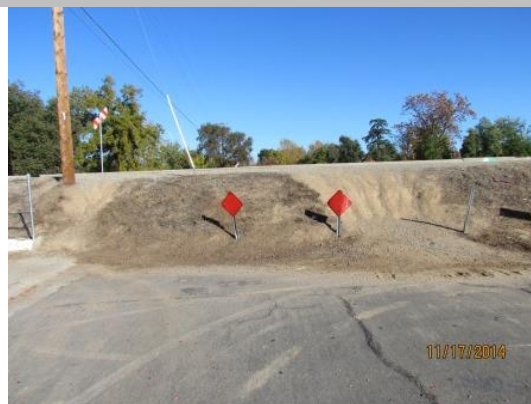
Photo 1 of 1 : SP\_2015\_NA0001\_51\_54\_20150317\_00032.jpg

LM Start	1.58	Rating **	A/W	Issue No.	54
LM End	1.58	Issue Type +	Ma	Location *	LS
Category	Earthen Levee			GPS Latitude/Longitude	
				Start	End
Item	Slope Stability			38.627251 °	38.627251 °
				-121.441460 °	-121.441460 °
DWR ID	DWR_NA0001_01_s_2012_54				
Action/Comments					
Repair the levee slope damaged by foot traffic and prevent access where possible.

Slope stability due to foot traffic needs to be monitored.

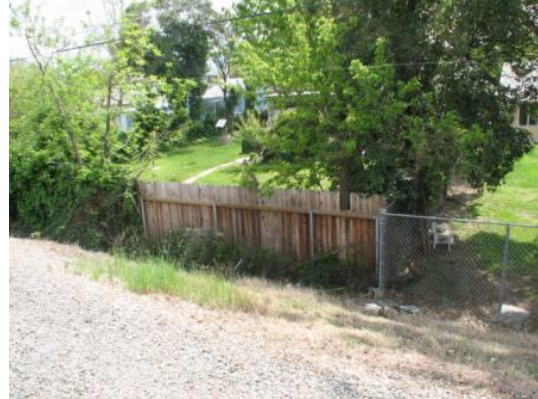
Photo 1 of 1 : SP\_2015\_NA0001\_51\_9\_20150317\_00008.jpg

LM Start	1.81	Rating **	M	Issue No.	9
LM End	1.81	Issue Type +	En	Location *	LS
Category	Earthen Levee			GPS Latitude/Longitude	
				Start	End
Item	Encroachments			38.627880 °	38.627880 °
				-121.437368 °	-121.437368 °
DWR ID	DWR_NA0001_01_s _ 2012_9				
Action/Comments					
Fence					
Inspector Comments: Dog-eared wooden fence is built near the levee slope and has partially fallen. Bushes are overgrown. Fence has fallen over. Portion of the fence has been replaced.

04/13/2011 Portion of fence has been replaced, assume that this is the portion that fell down and was referenced in the fall '10 inspection.

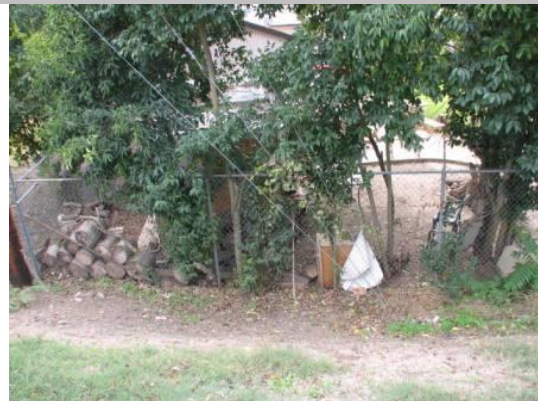
Photo 1 of 1 : SP\_2015\_NA0001\_51\_33\_20150317\_00026.jpg

11/17/2011 Wooden structure is built within 15' of the levee toe.

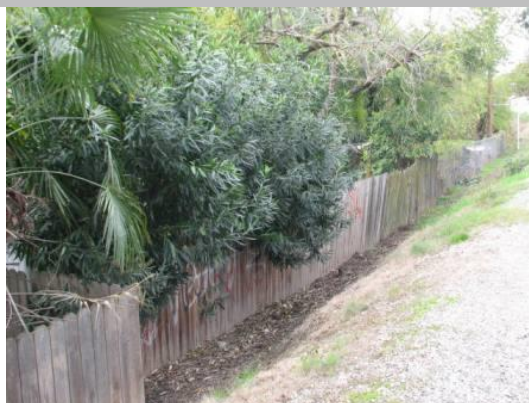
Photo 1 of 1 : SP\_2015\_NA0001\_51\_6\_20150317\_00005.jpg

11/17/2011 Wooden privacy fence built at the levee toe.

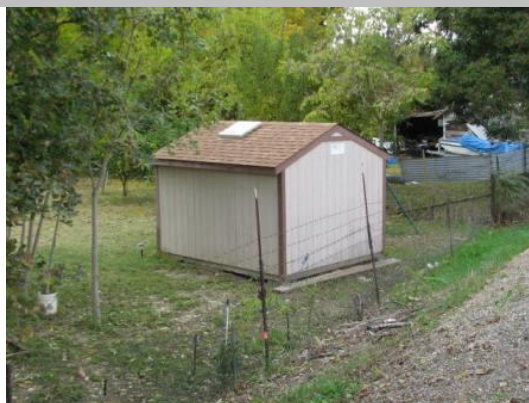
Photo 1 of 1 : SP\_2015\_NA0001\_51\_27\_20150317\_00021.jpg

11/17/2011 Wooden structure is within 15' of the levee toe.

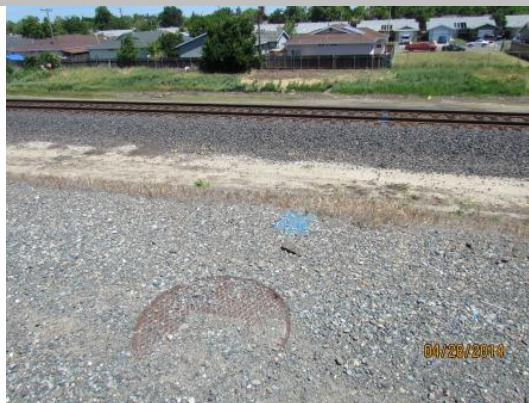
Photo 1 of 1 : SP\_2015\_NA0001\_52\_8\_20150317\_00004.jpg

View of the pipe from levee crown.

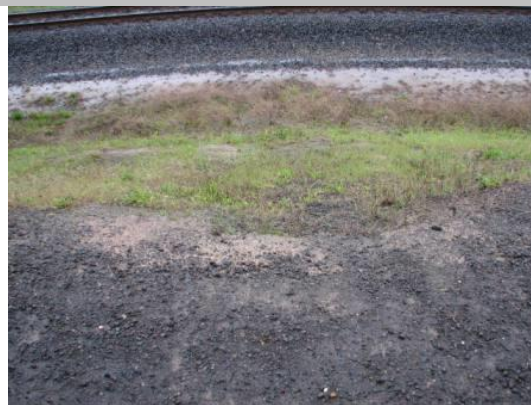
Photo 1 of 2 : SP\_2015\_NA0001\_52\_150\_20150317\_00006.jpg

03/14/2012 Photo shows depression, the issue has not gotten any worse since the fall 2011 inspection.

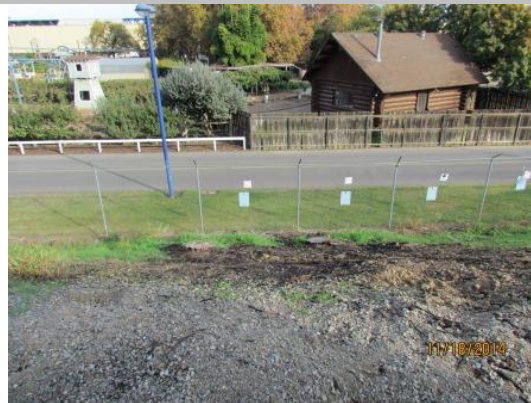
Photo 1 of 1 : SP\_2015\_NA0001\_490\_23\_20150317\_00004.jpg

View of the tree stump on the landside levee slope.

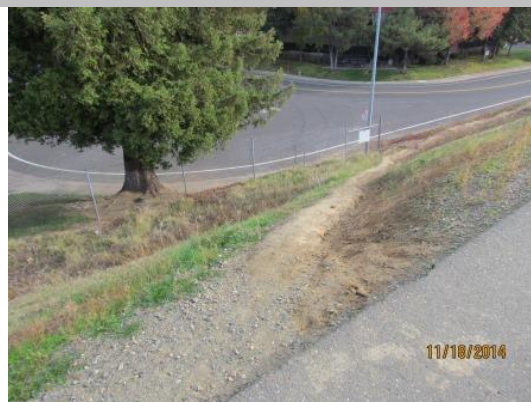
Photo 1 of 1 : SP\_2015\_NA0001\_490\_9\_20150317\_00002.jpg

View of the erosion on landside levee slope due to pedestrian traffic.

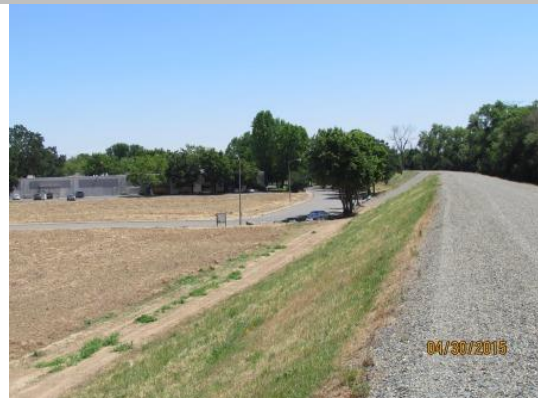
Photo 1 of 1 : SP\_2015\_NA0001\_490\_25\_20150504\_00012.jpg

View of the acceptable vegetation on levee slope.

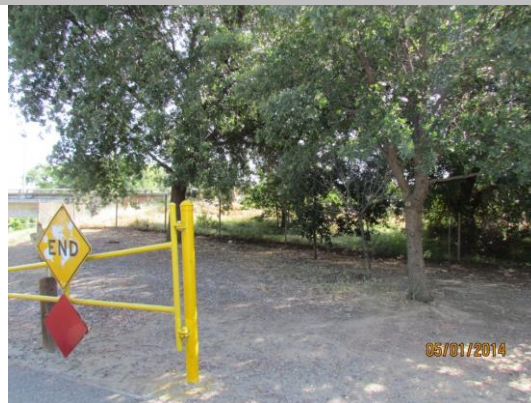
Photo 1 of 1 : SP\_2015\_NA0001\_55\_177\_20150317\_00155.jpg

View of the landscaping on the levee crown.

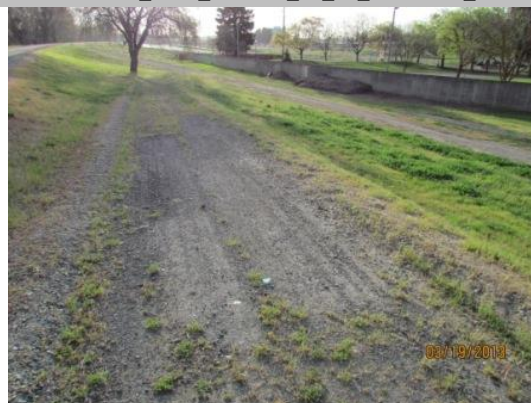
Photo 1 of 1 : SP\_2015\_NA0001\_55\_67\_20150317\_00052.jpg

View of improperly graded bicycle ramp.

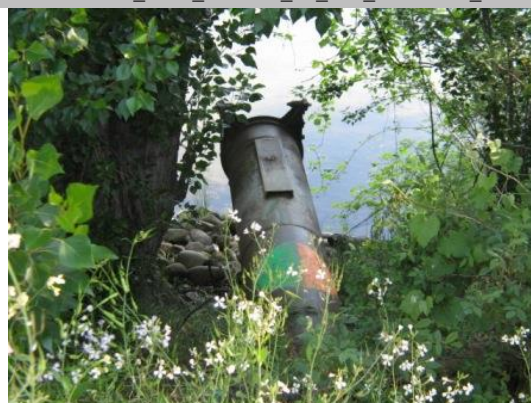
Photo 1 of 1 : SP\_2015\_NA0001\_55\_244\_20150317\_00190.jpg

Discharge pipe from printing shop into American River.

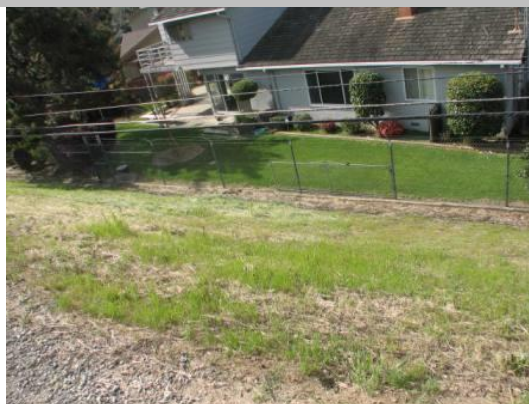
Photo 1 of 1 : SP\_2015\_NA0001\_55\_195\_20150317\_00168.jpg

04/14/2011 Landscape removed, chainlink fence remains.

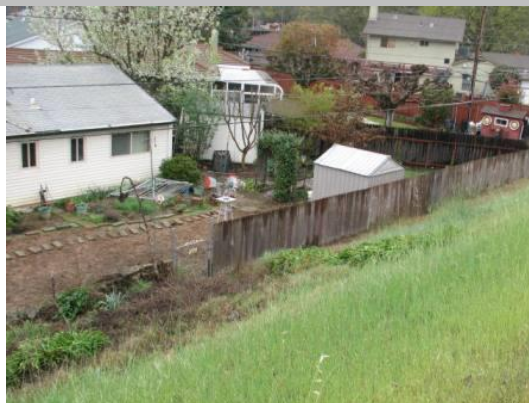
Photo 1 of 1 : SP\_2015\_NA0001\_55\_29\_20150317\_00028.jpg

03/16/2012 Flowering bush is dormant, landscaping on levee slope and wooden privacy fence.

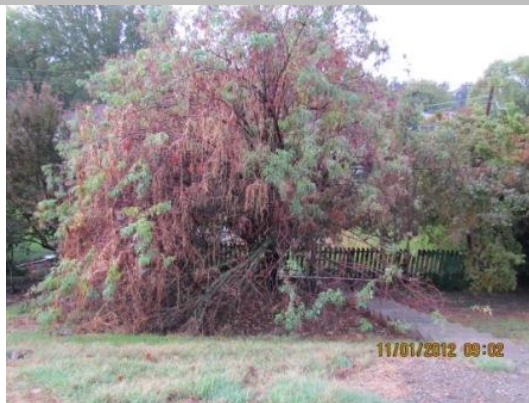
Photo 1 of 1 : SP\_2015\_NA0001\_55\_253\_20150317\_00193.jpg

View of large elderberry bush obstructing visibility and access.

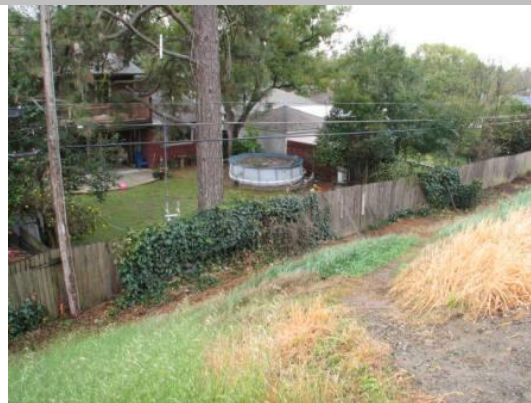
Photo 1 of 1 : SP\_2015\_NA0001\_55\_199\_20150317\_00171.jpg

03/16/2012 Wood privacy fence completely obstructs access and visibility.

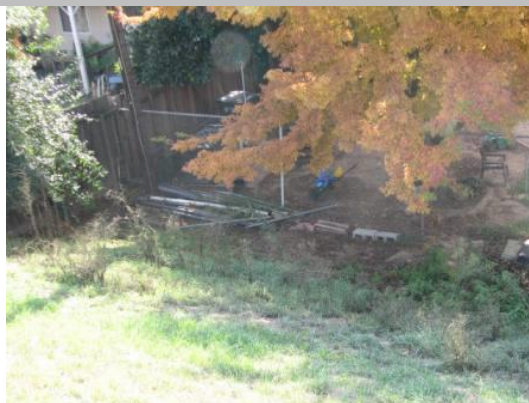
Photo 2 of 2 : SP\_2015\_NA0001\_55\_739\_20150317\_00195.jpg

11/15/2011 Debris on levee side of fence. This item was noted in the USACE PI.

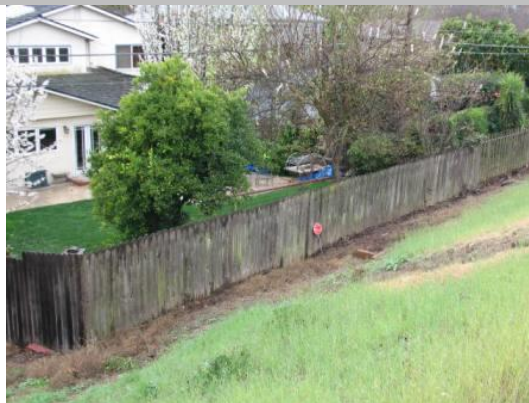
Photo 1 of 1 : SP\_2015\_NA0001\_55\_42\_20150317\_00033.jpg

03/16/2012 Wood privacy fence completely obstructs access and visibility.

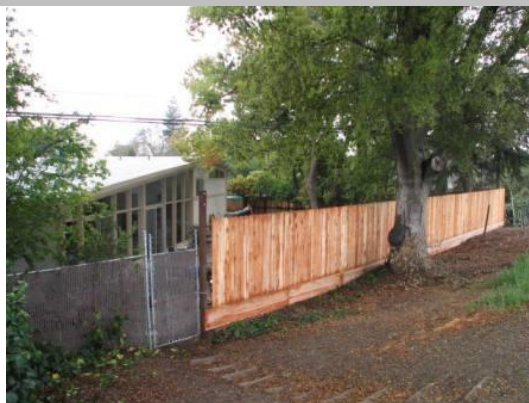
Photo 1 of 1 : SP\_2015\_NA0001\_55\_208\_20150317\_00178.jpg

03/16/2012 Wood privacy fence completely obstructs access and visibility.

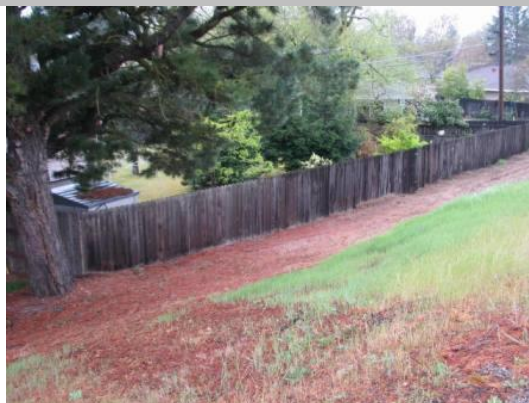
Photo 1 of 1 : SP\_2015\_NA0001\_55\_49\_20150317\_00039.jpg

03/16/2012 Wood privacy fence completely obstructs access and visibility.

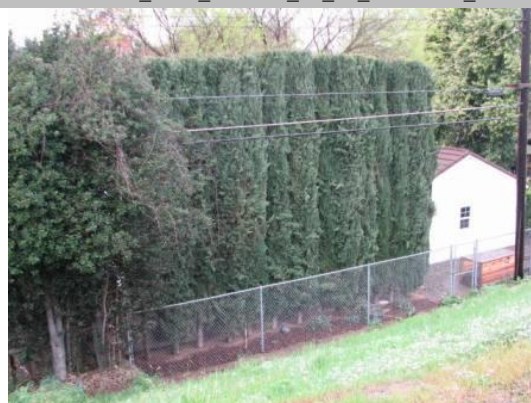
Photo 1 of 1 : SP\_2015\_NA0001\_55\_52\_20150317\_00041.jpg

03/16/2012 Landscaping obstructs visibility and access.

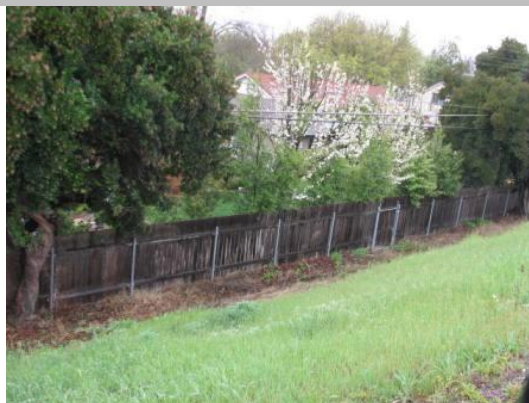
Photo 1 of 1 : SP\_2015\_NA0001\_55\_55\_20150317\_00044.jpg

03/16/2012 Wood privacy fence completely obstructs access and visibility.

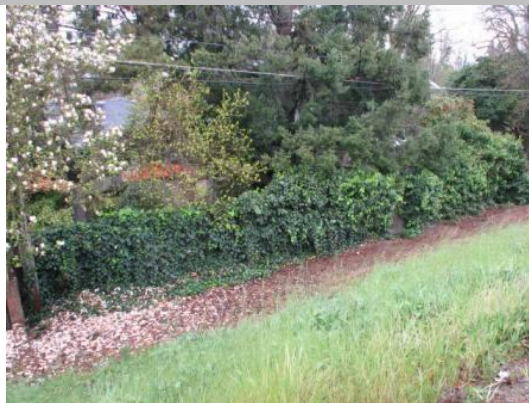
Photo 1 of 1 : SP\_2015\_NA0001\_55\_61\_20150317\_00048.jpg

03/16/2012 Landscaping obstructs access and visibility.

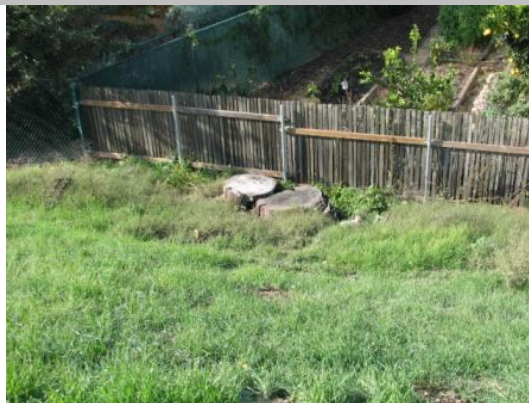
Photo 1 of 1 : SP\_2015\_NA0001\_55\_741\_20150317\_00197.jpg

11/15/2011 Stump at levee toe.

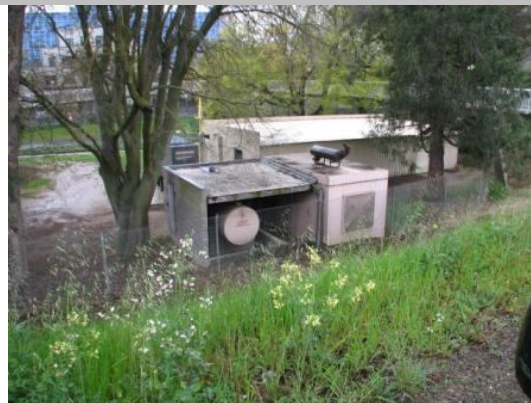
Photo 1 of 1 : SP\_2015\_NA0001\_55\_73\_20150317\_00056.jpg

03/16/2012 Structure for generator is within 5' of levee toe.

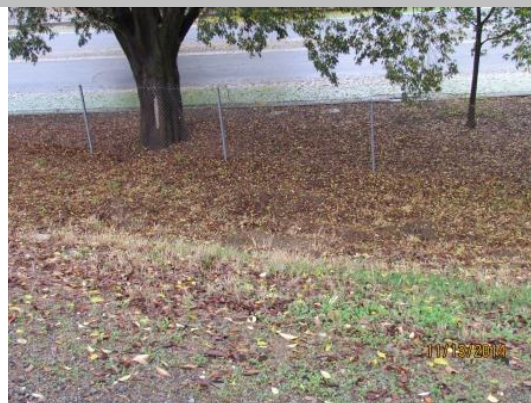
Photo 1 of 1 : SP\_2015\_NA0001\_55\_240\_20150317\_00189.jpg

View of a rodent burrow at the landside levee toe.

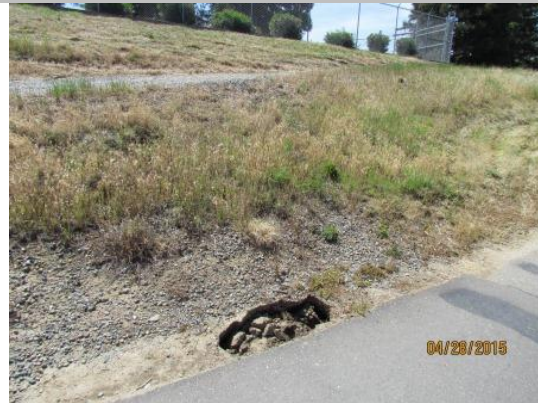
Photo 1 of 1 : SP\_2015\_NA0001\_55\_241\_20150504\_00216.jpg

View of the sinkhole at the waterside levee toe.

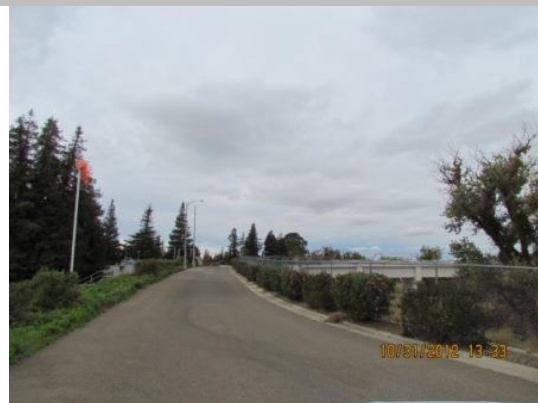
Photo 1 of 1 : SP\_2015\_NA0001\_55\_140\_20150317\_00120.jpg

View of landscaping at waterside hinge obstructing visibility.

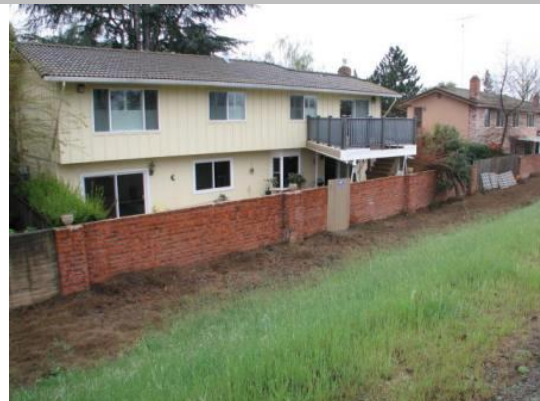
Photo 1 of 1 : SP\_2015\_NA0001\_55\_85\_20150317\_00068.jpg

03/16/2012 Brick wall completely obstructs access and visibility.

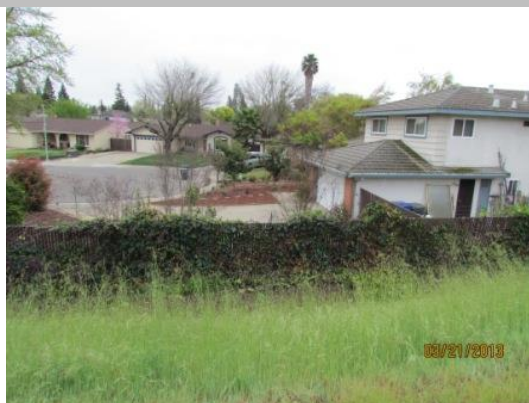
Photo 1 of 1 : SP\_2015\_NA0001\_55\_225\_20150317\_00182.jpg

View of the landscaping at the levee toe.

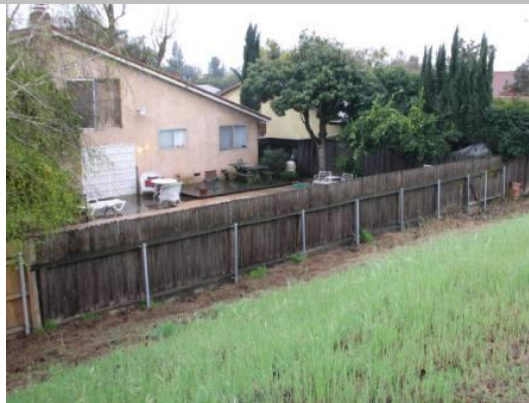
Photo 1 of 1 : SP\_2015\_NA0001\_55\_94\_20150317\_00077.jpg

03/16/2012 Wood privacy fence completely obstructs access and visibility.

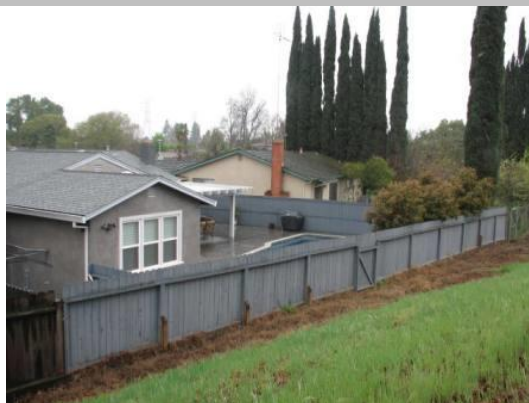
Photo 1 of 1 : SP\_2015\_NA0001\_55\_103\_20150317\_00086.jpg

03/16/2012 Wood privacy fence completely obstructs access and visibility.

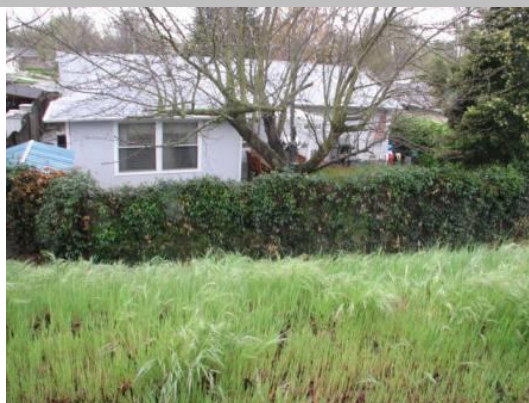
Photo 1 of 1 : SP\_2015\_NA0001\_55\_108\_20150317\_00091.jpg

03/16/2012 Landscaping obstructs visibility and access.

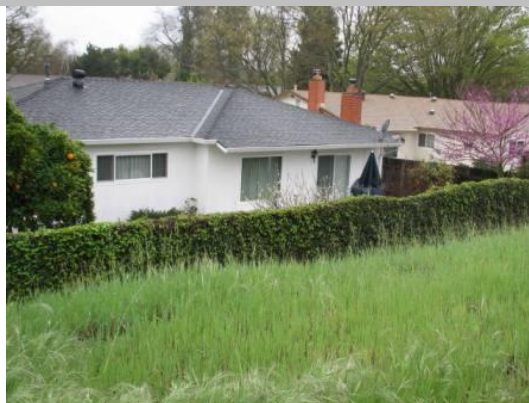
Photo 1 of 1 : SP\_2015\_NA0001\_55\_114\_20150317\_00097.jpg

03/16/2012 Ivy on chainlink fence completely obstructs visibility and access.

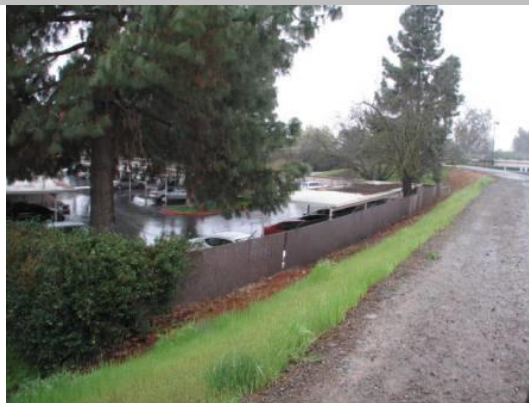
Photo 1 of 1 : SP\_2015\_NA0001\_55\_235\_20150317\_00184.jpg

03/16/2012 Chainlink fence with privacy slats and barbed wire obstruct visibility and access.

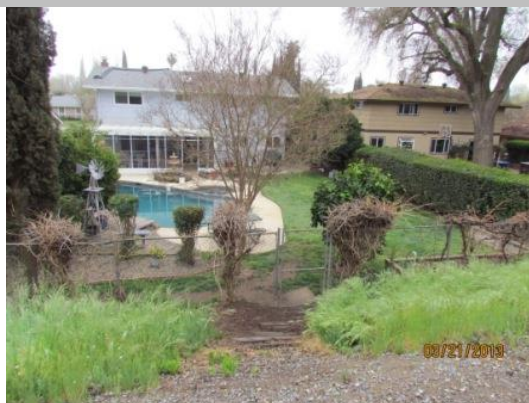
Photo 1 of 1 : SP\_2015\_NA0001\_55\_124\_20150317\_00106.jpg

View of landscaping at levee toe.

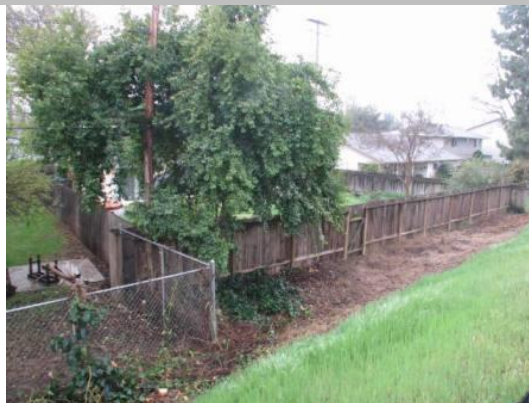
Photo 1 of 1 : SP\_2015\_NA0001\_55\_128\_20150317\_00109.jpg

03/16/2012 Wood privacy fence completely obstructs access and visibility.

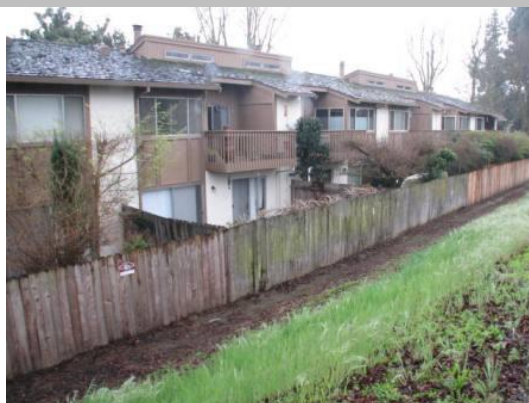
Photo 1 of 1 : SP\_2015\_NA0001\_55\_141\_20150317\_00121.jpg

03/16/2012 Wood privacy fence completely obstructs access and visibility.

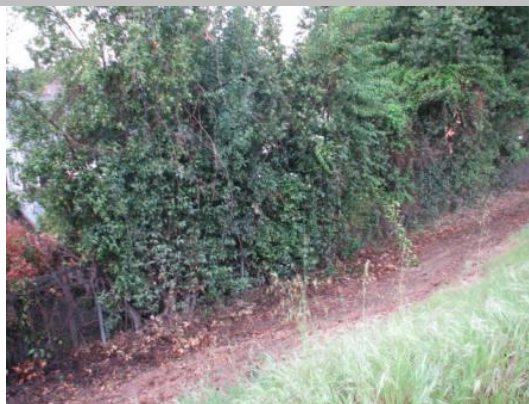
Photo 1 of 1 : SP\_2015\_NA0001\_55\_157\_20150317\_00137.jpg

03/16/2012 Landscaping obstructs visibility

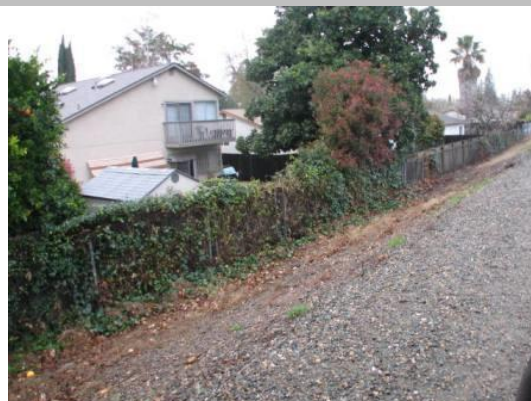
Photo 1 of 1 : SP\_2015\_NA0001\_55\_163\_20150317\_00143.jpg

03/16/2012 Wood privacy fence completely obstructs access and visibility.

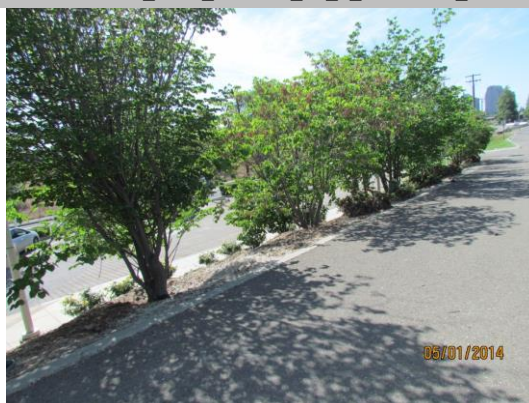
Photo 1 of 1 : SP\_2015\_NA0001\_56\_5\_20150317\_00002.jpg

View of the landscaping on the landside levee slope at the City intake facility.

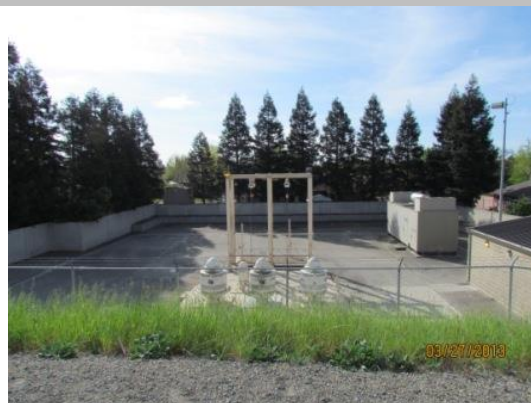
Photo 1 of 1 : SP\_2015\_NA0001\_57\_8\_20150317\_00001.jpg

View of the pumping plant at the landside levee toe.

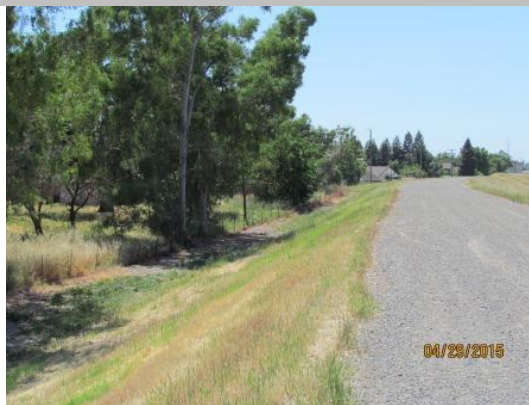
Photo 1 of 1 : SP\_2015\_NA0001\_57\_9\_20150504\_00005.jpg

View of the acceptable vegetation control on the levee slope.

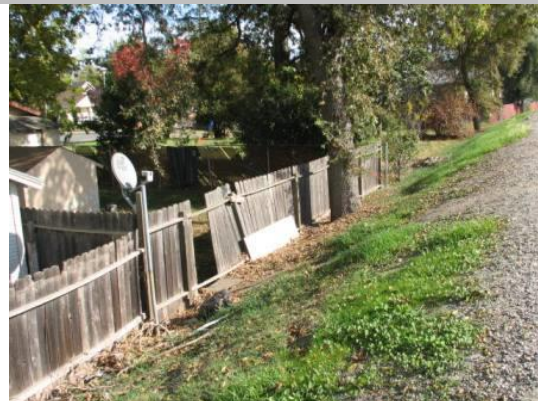
Photo 1 of 1 : SP\_2015\_NA0001\_58\_4\_20150317\_00003.jpg

11/17/2011 Wooden privacy fence is constructed at the toe.

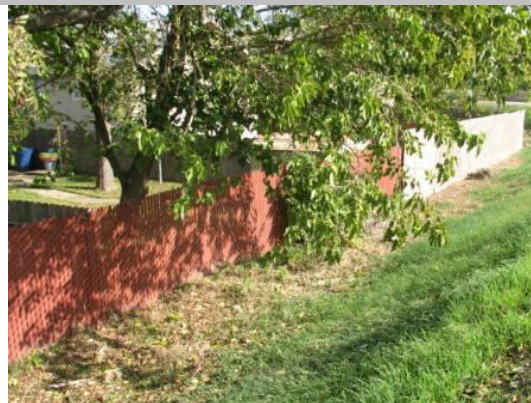
Photo 1 of 1 : SP\_2015\_NA0001\_58\_27\_20150317\_00024.jpg

11/17/2011 Privacy fence is constructed at the toe.

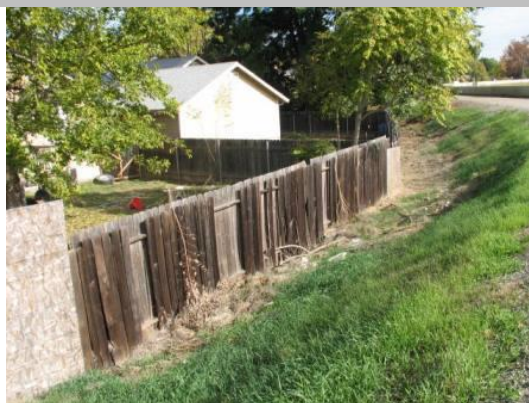
Photo 1 of 1 : SP\_2015\_NA0001\_58\_25\_20150317\_00022.jpg

11/17/2011 Wooden privacy fence is constructed at the toe.

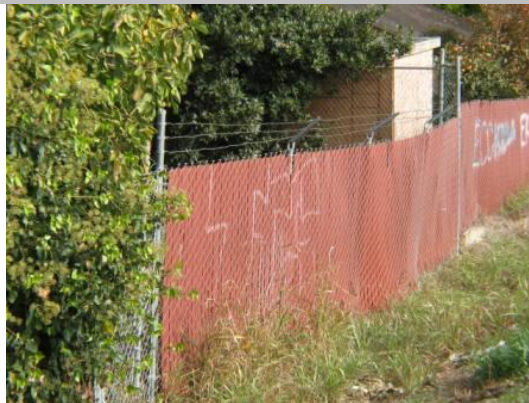
Photo 1 of 1 : SP\_2015\_NA0001\_58\_12\_20150317\_00010.jpg

11/17/2011 Barbed wire topped privacy fence is located at the toe.

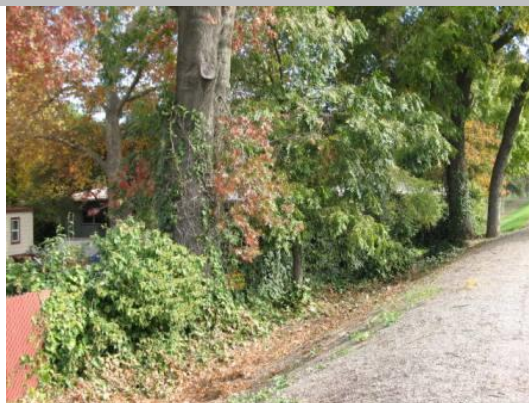
Photo 1 of 2 : SP\_2015\_NA0001\_58\_15\_20150317\_00013.jpg

11/17/2011 Dense vegetation at the toe.

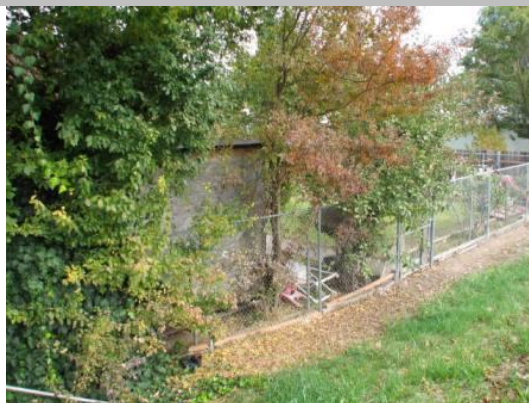
Photo 1 of 1 : SP\_2015\_NA0001\_58\_22\_20150317\_00019.jpg

11/17/2011 Building is too close to the levee toe and obstructs visibility and access.

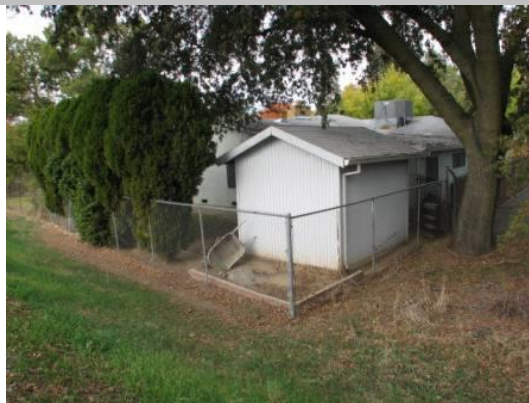
Photo 1 of 1 : SP\_2015\_NA0001\_58\_21\_20150317\_00018.jpg

11/17/2011 Building and landscaping are too close to the levee toe.

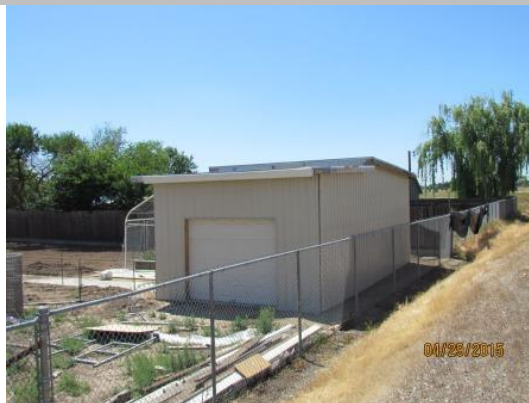
Photo 1 of 1 : SP\_2015\_NA0001\_59\_15\_20150504\_00016.jpg

View of the building within 10 feet of landside levee toe, facing downstream.

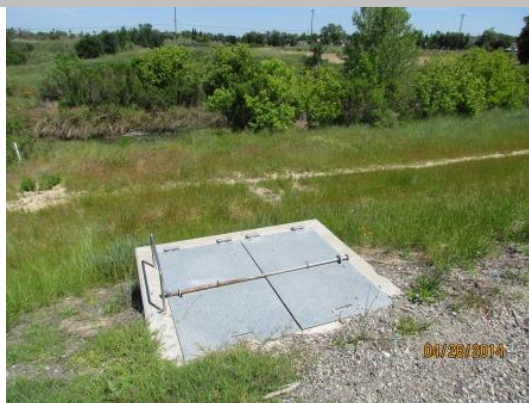
Photo 1 of 1 : SP\_2015\_NA0001\_59\_21\_20150317\_00012.jpg

View of the pipe from levee crown.

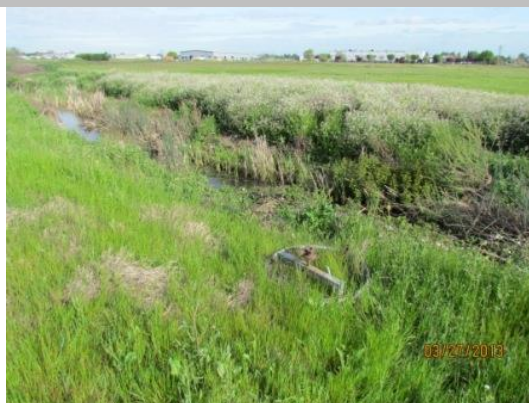
Photo 1 of 1 : SP\_2015\_NA0001\_59\_3\_20150317\_00003.jpg

View of the gate valve at the waterside levee hinge.

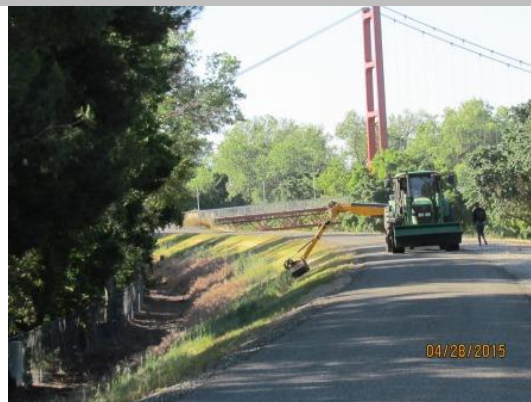
Photo 1 of 1 : SP\_2015\_NA0001\_60\_25\_20150504\_00015.jpg

View of the vegetation control in progress.

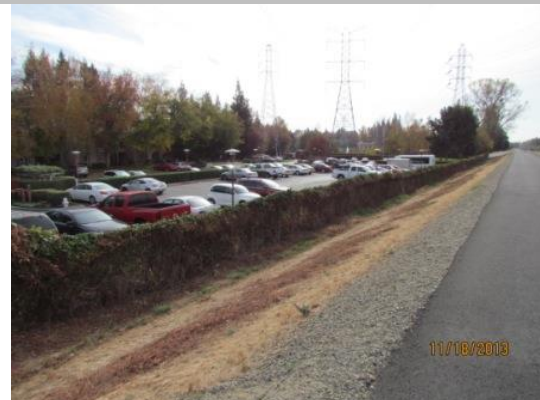
Photo 1 of 1 : SP\_2015\_NA0001\_60\_2\_20150317\_00002.jpg

View of the trimmed vegetation on the chain linked fence still obstructing visibility.

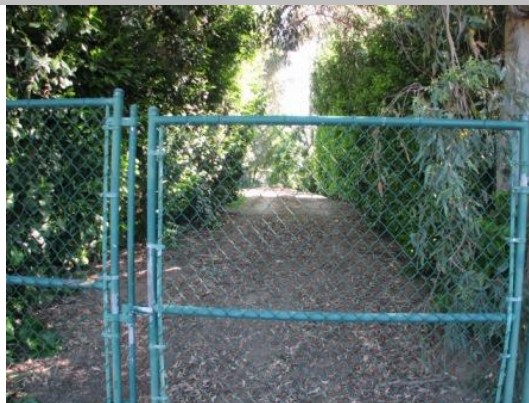
Photo 1 of 1 : SP\_2015\_NA0001\_61\_16\_20150317\_00006.jpg

Levee encroached on by property owners north of Arden Way. This section is not reasonably accessible.

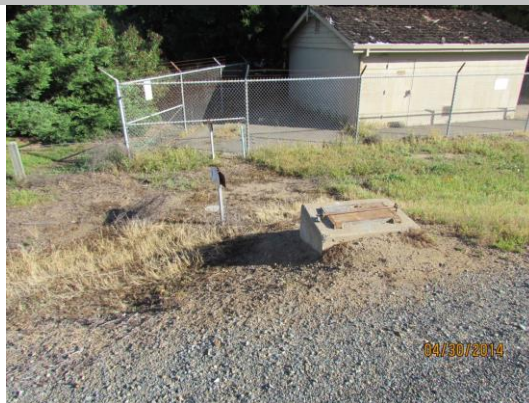
Photo 1 of 1 : SP\_2015\_NA0001\_61\_11\_20150317\_00005.jpg

View of the pipe at the landside levee hinge.

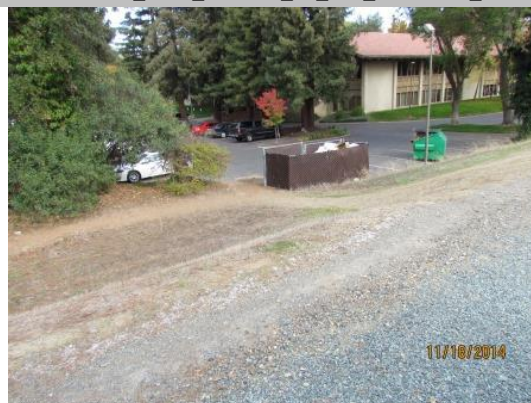
Photo 1 of 1 : SP\_2015\_NA0001\_61\_116\_20150317\_00010.jpg

View of the erosion on the landside levee slope caused by pedestrian foot traffic.

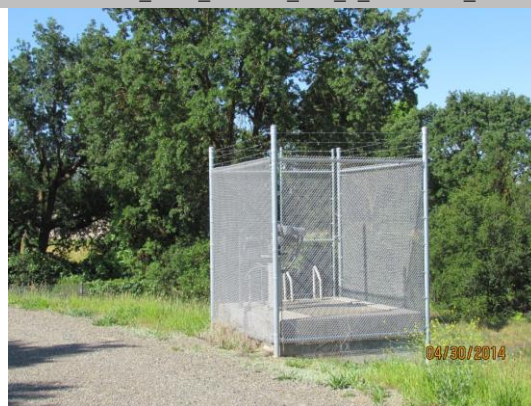
Photo 1 of 1 : SP\_2015\_NA0001\_438\_3\_20150317\_00003.jpg

View of the access hole at the waterside levee hinge.

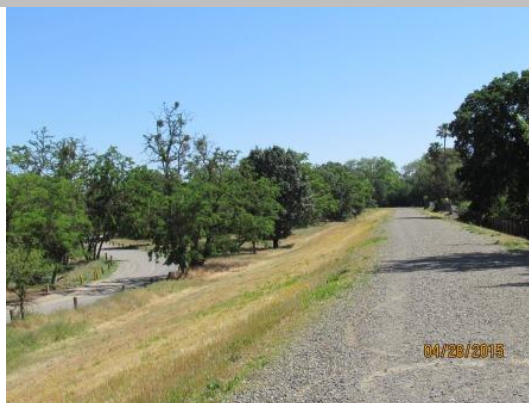
Photo 1 of 1 : SP\_2015\_NA0001\_438\_9\_20150504\_00006.jpg

View of the acceptable vegetation on the levee slope.
